Roof Repairs & Re-Roofing with Swifts

Follow these simple guidelines to comply with the law and keep Swifts safe and breeding in your roof.

Repairing & renewing roofs without destroying nests

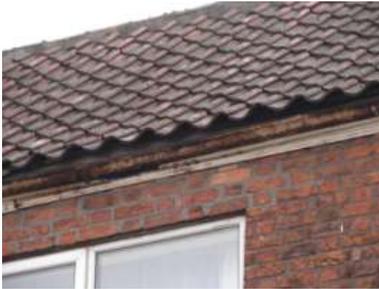
Swifts may nest behind the aperture in the cornice above the right hand window in the photo above. A simple solution is preserve the nest space to cut an aperture in the replacement cornice, (as shown on the right) or to offset the new cornice with battens so the Swifts can enter underneath it.
Photo © Barry Hancock

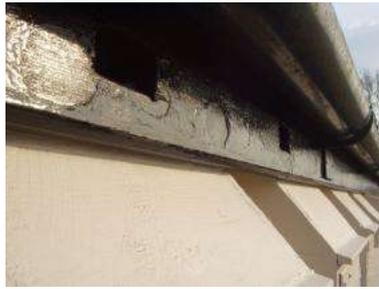
Holes cut in the facing boards let the Swifts reach their nests under the roof, on top of the wall of this chapel. This sort of humane and pragmatic solution costs nothing, and just takes care to match the entrances with the old ones.

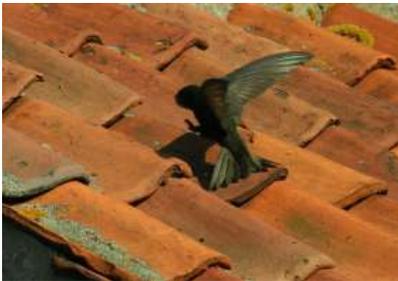
A Swift entering a roof via a displaced pantile. The nest is on the roofing felt below, held in place by the battens. This sort of nest place can be protected by wedging up the replacement tiles wherever the nest entrances are. The access gap needed by the Swifts is just 30mm.

Under tiles - reinstate the tiles keeping the old gaps where the Swifts gained entry exactly where they were. You can do this easily by inserting wedges of cement and pieces of tile beneath the new tiles, to lift them by 30mm to provide access for the Swifts.

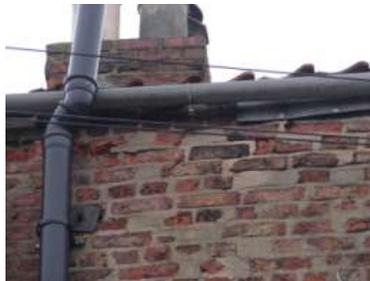
Swifts can often be found nesting in gaps in brickwork behind pipes, flashings and gutters. Great care is needed when replacing these items not to destroy access. The simplest solution is to keep the holes open, place flashing and pipe brackets so as not to obstruct access.

Behind flashings fascias and bargeboards- offset or lengthen flashings bargeboards and ridge/end tiles to let the Swifts back in without affecting weatherproofing.

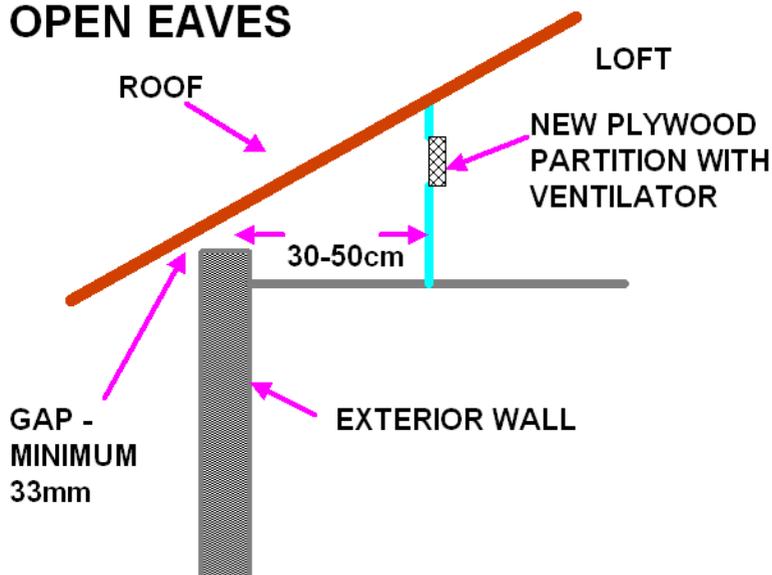
KEEPING NEST PLACES IN OLD OPEN EAVES

If you have to, install a ventilated plywood partition at least 30cm inside the loft to enclose the Swift nest areas and make the loft area usable, as shown below. *More drawings and details are shown on the last page.*

Eaves nests- leaving the eaves open is the simplest & best solution or cut slots in the soffit or facing boards to match the old entrances

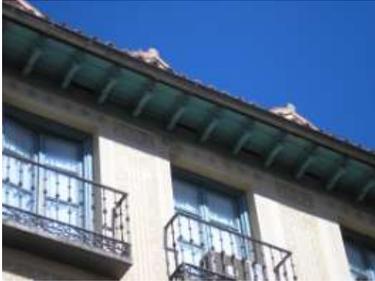
Swifts breed inside the eaves of this hotel at the Escorial, in Spain. Access slots (seen as dark lines at the top of the wall) are left free for them to enter and also to ventilate the roof space.

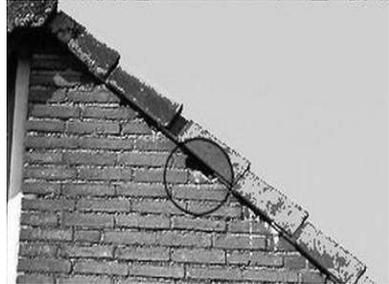
Swifts nest under the tiles on the brick ends of this roof. Repairs would evict them, but leaving the bricks as they are and fitting deeper tiles, offset to maintain the Swifts' access from below, will provide weather proofing and still let the Swifts nest.

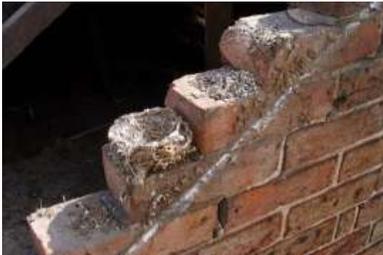
A Swift nest on a gable brick end, exposed when the barge boards were removed. Swifts can nest in very restricted places.

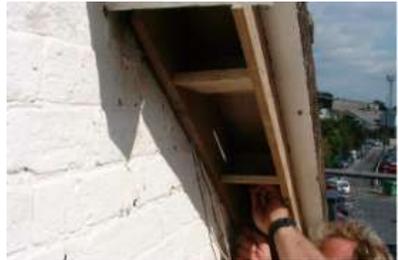
The gable brick ends shown exposed on the left have been fitted with bargeboards containing staircase type nest boxes. These will be faced with a plank with entrance holes cut for the Swifts to access the new nest places inside.

Inside gables - either leave well alone or else fit simple wooden nest places behind the bargeboards.

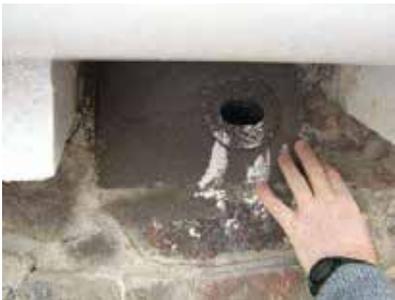
A Schwegler "Swift Brick" inserted into previously open eaves to provide a replacement Swift nesting place. The roof of this NHS hospital had to be sealed to meet hygiene requirements, but the Swifts' nests were saved.

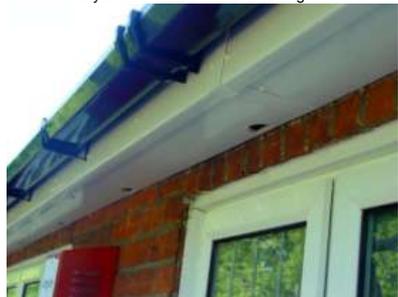
Plastic soffits and gutters have been fitted to this re-roofed house. Holes have been cut in the soffits close to the wall to provide access for the Swifts to their nests in the eaves.
